**SUMMARY REPORT FOR THE
TORCH LAKE AREA ASSESSMENT
TORCH LAKE NPL SITE
AND SURROUNDING AREAS
KEWEENAW PENINSULA, MICHIGAN**

Date Prepared	December 13, 2007
TDD Number	S05-0002-0708-020
Contract Number	EP-S5-06-04
Document Control Number	274-2A-ABDT
START Project Manager	Daniel M. Capone
Telephone No.	(906) 482-3085
U.S. EPA On-Scene Coordinator	Brian Kelly

EXECUTIVE SUMMARY

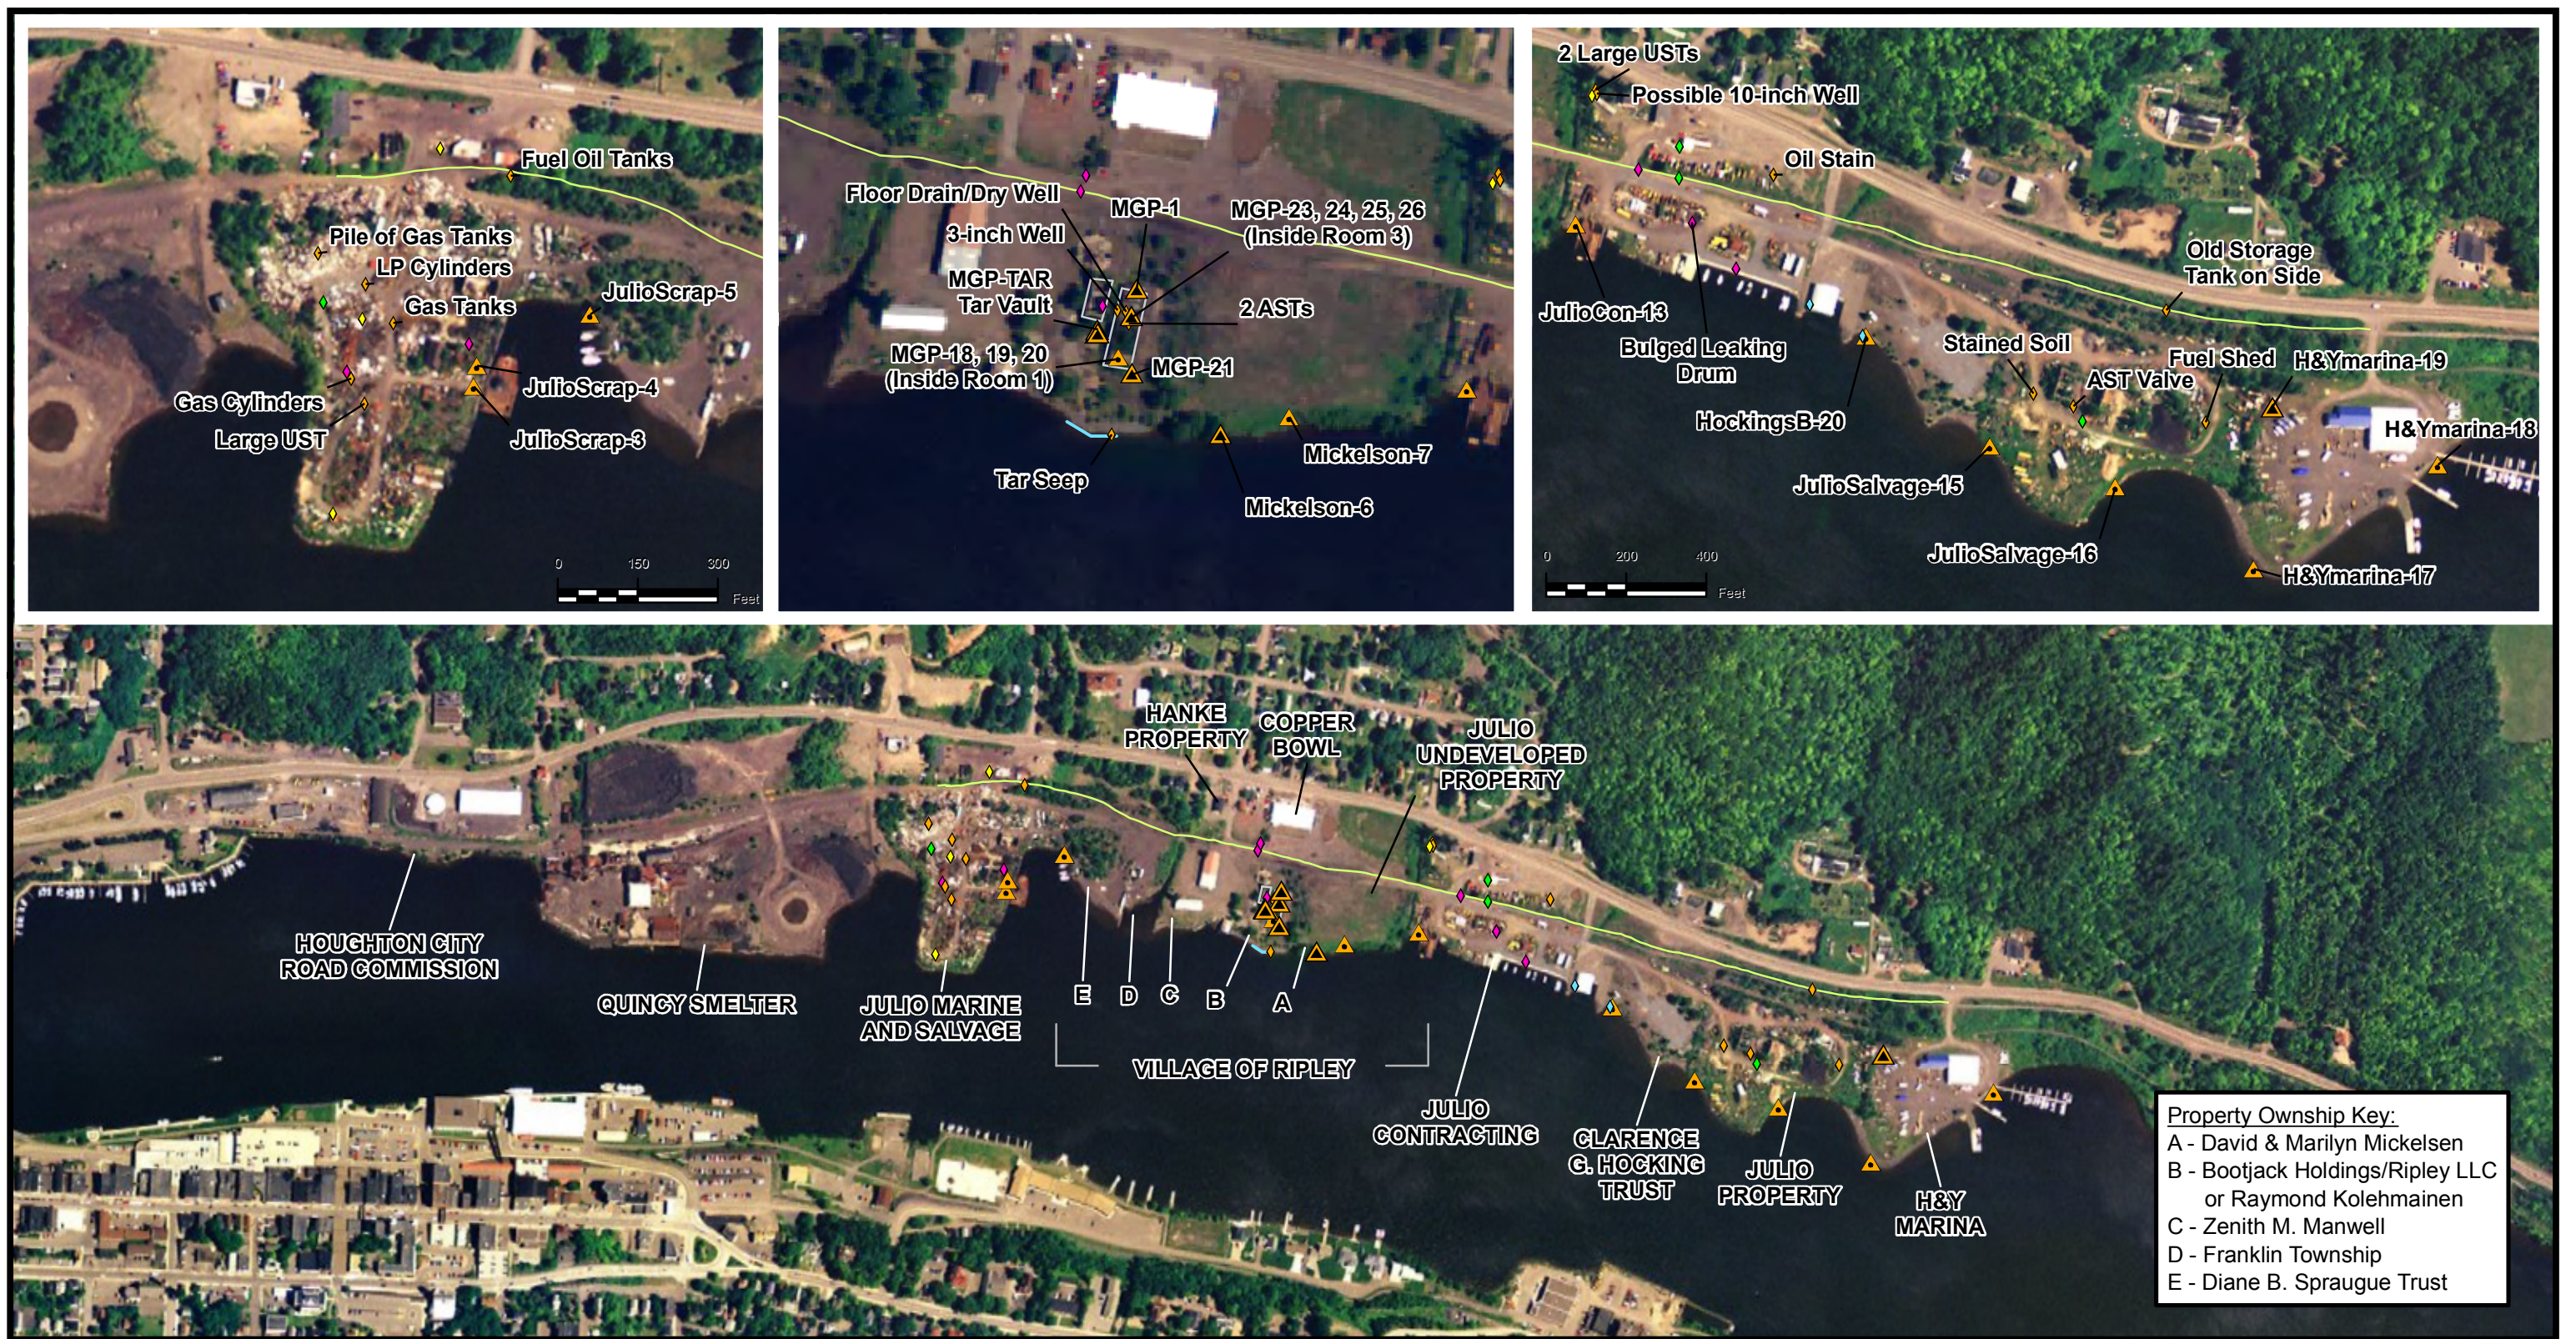
Figure 2a

The Julio Marine and Salvage is a commercial scrap metal recycling yard (**Figure 2a**). Drums, ASTs, USTs, electrical equipment, compressed-gas cylinders labeled as propane and other materials, crushed gas tanks, engines, automobiles with oil and gas tanks present, and car batteries were observed on site. With the exception of the car batteries, automobiles, and some of the drums, all items appeared empty and stacked with like materials. Large piles of stamp sands were also present on site, stockpiled for creating and repairing roads within the scrap yard. Per the scope of the AA, XRF screening was conducted only at the property shoreline.

- Evidence of past fires in more than one location;
- Several drums with unknown contents stored within a tall metal vault;
- A large pile of stained soil mixed with metal debris, approximately 20 feet long, five feet wide, and three feet tall, located near a scale station; and
- An oily sheen west of the scrap yard main building.

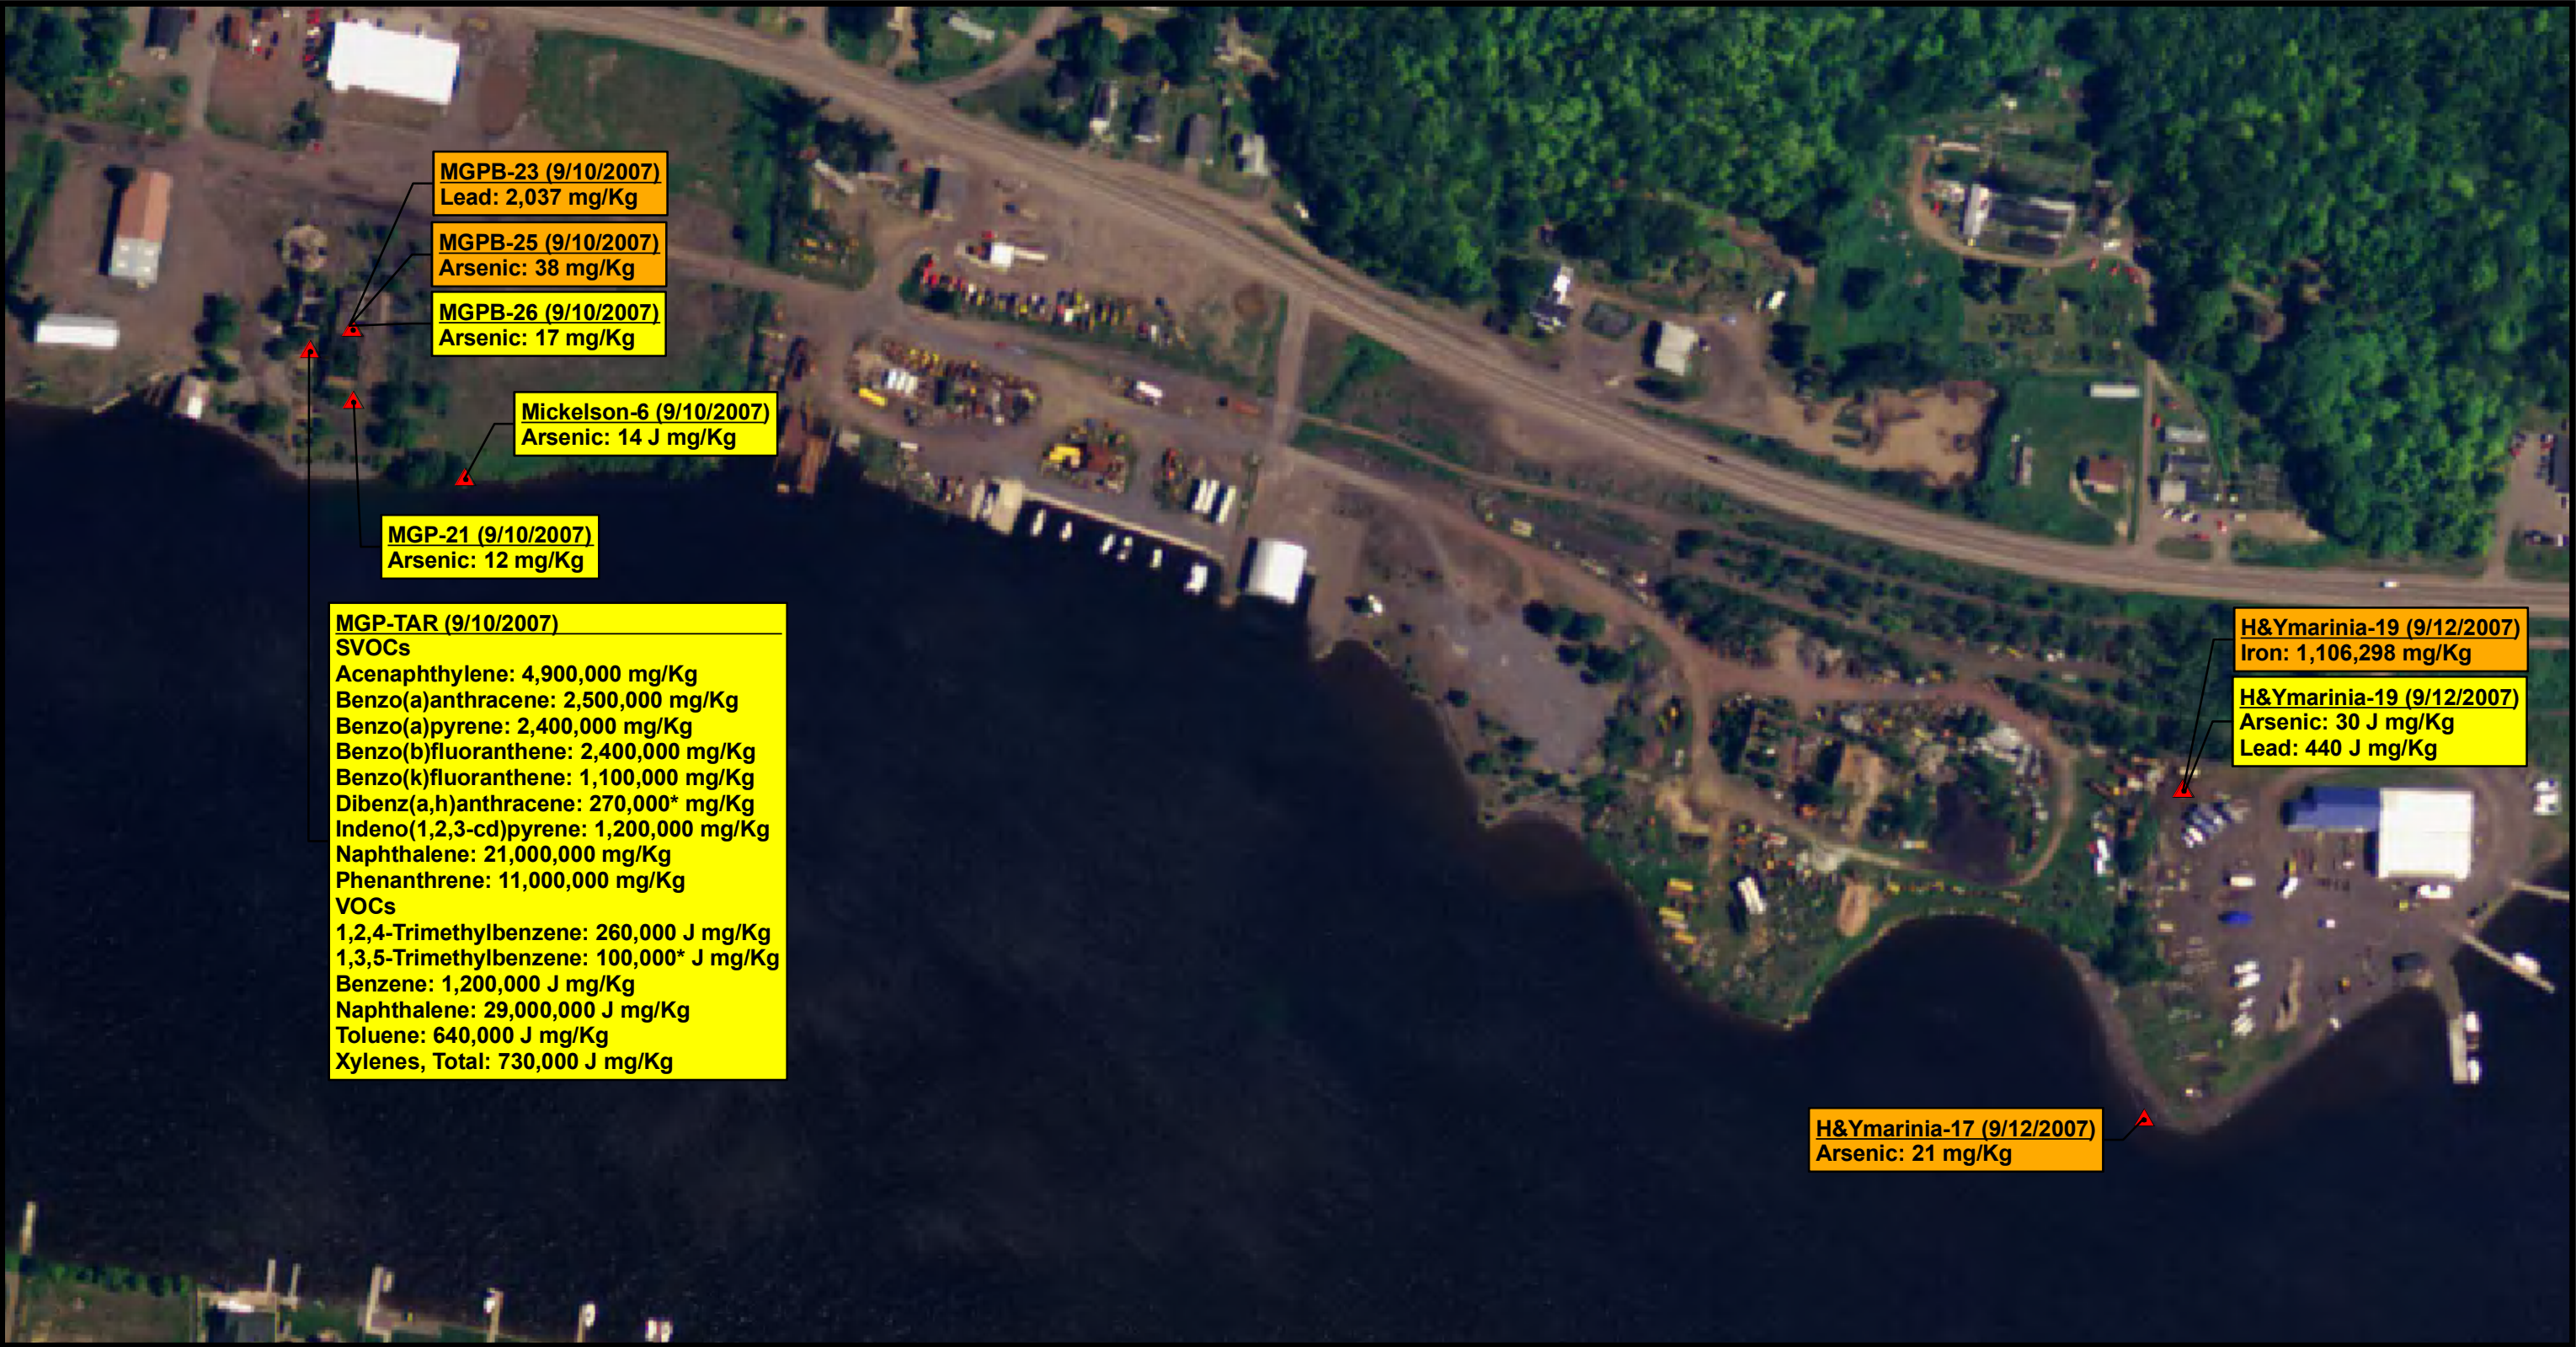
AOI Nos. 7 and 15
SITE FEATURES AND XRF LOCATIONS
TORCH LAKE AREA ASSESSMENT
KEWEENAW PENINSULA, MICHIGAN
October 2007

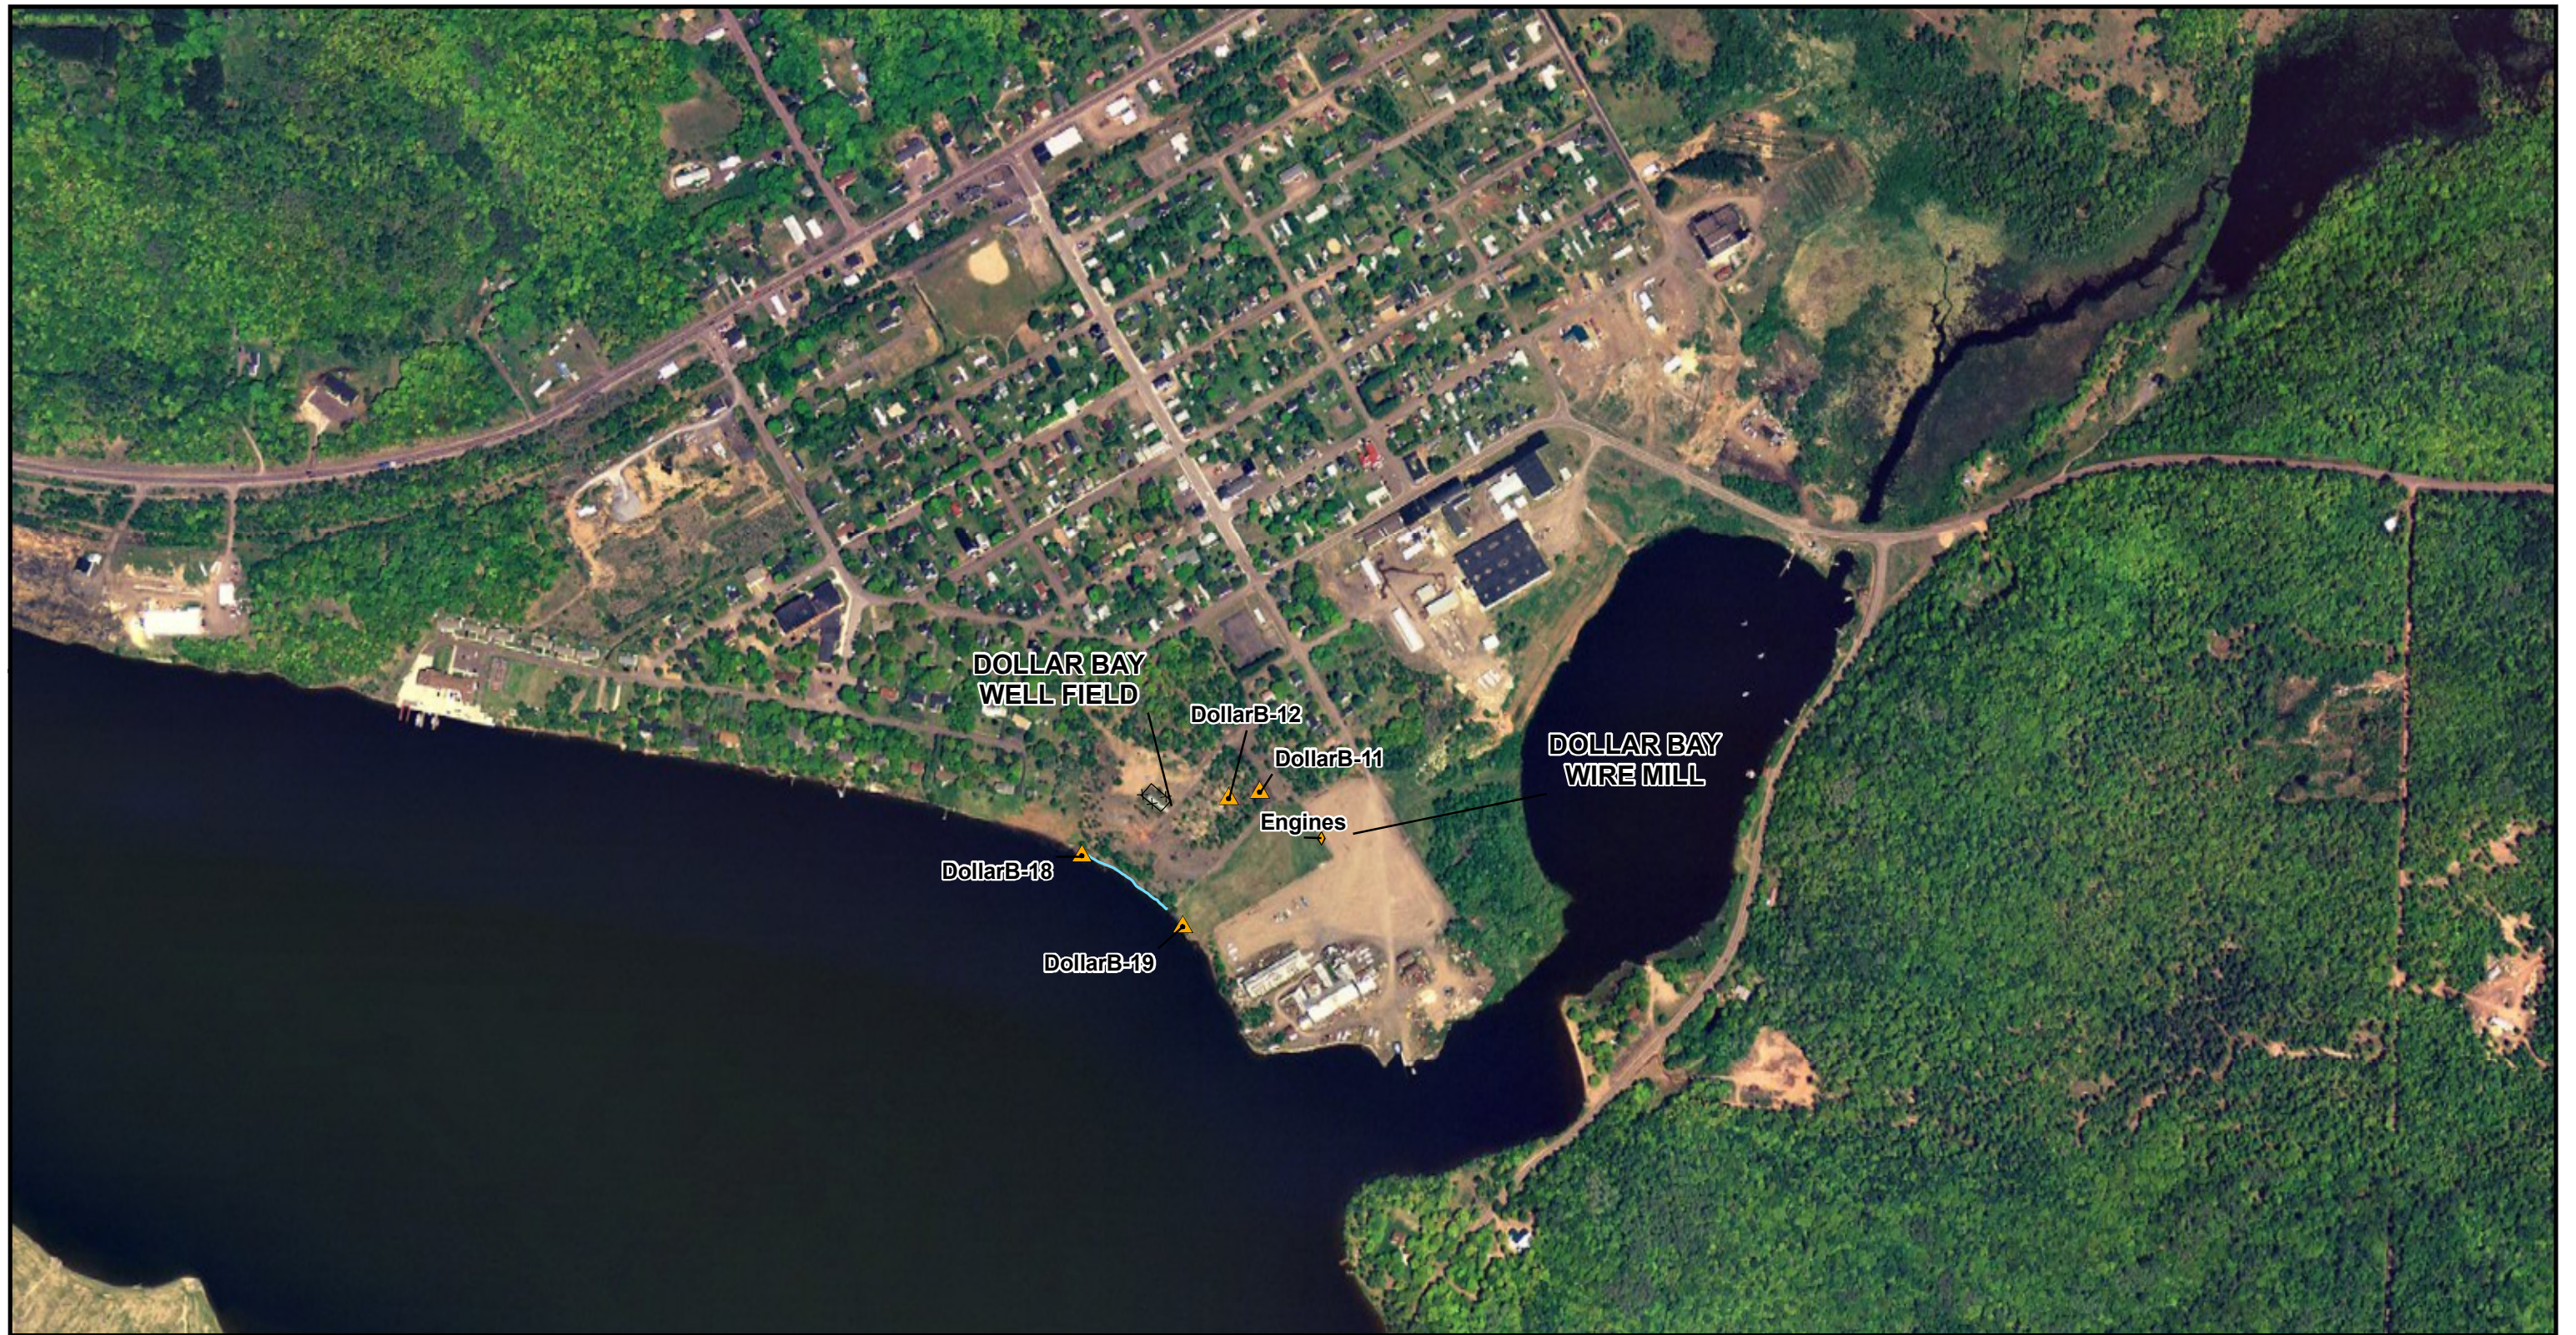
Figure 2b

AOI Nos. 7 and 15
RDCC EXCEEDANCES IN SOIL
TORCH LAKE AREA ASSESSMENT
KEWEENAW PENINSULA, MICHIGAN
October 2007

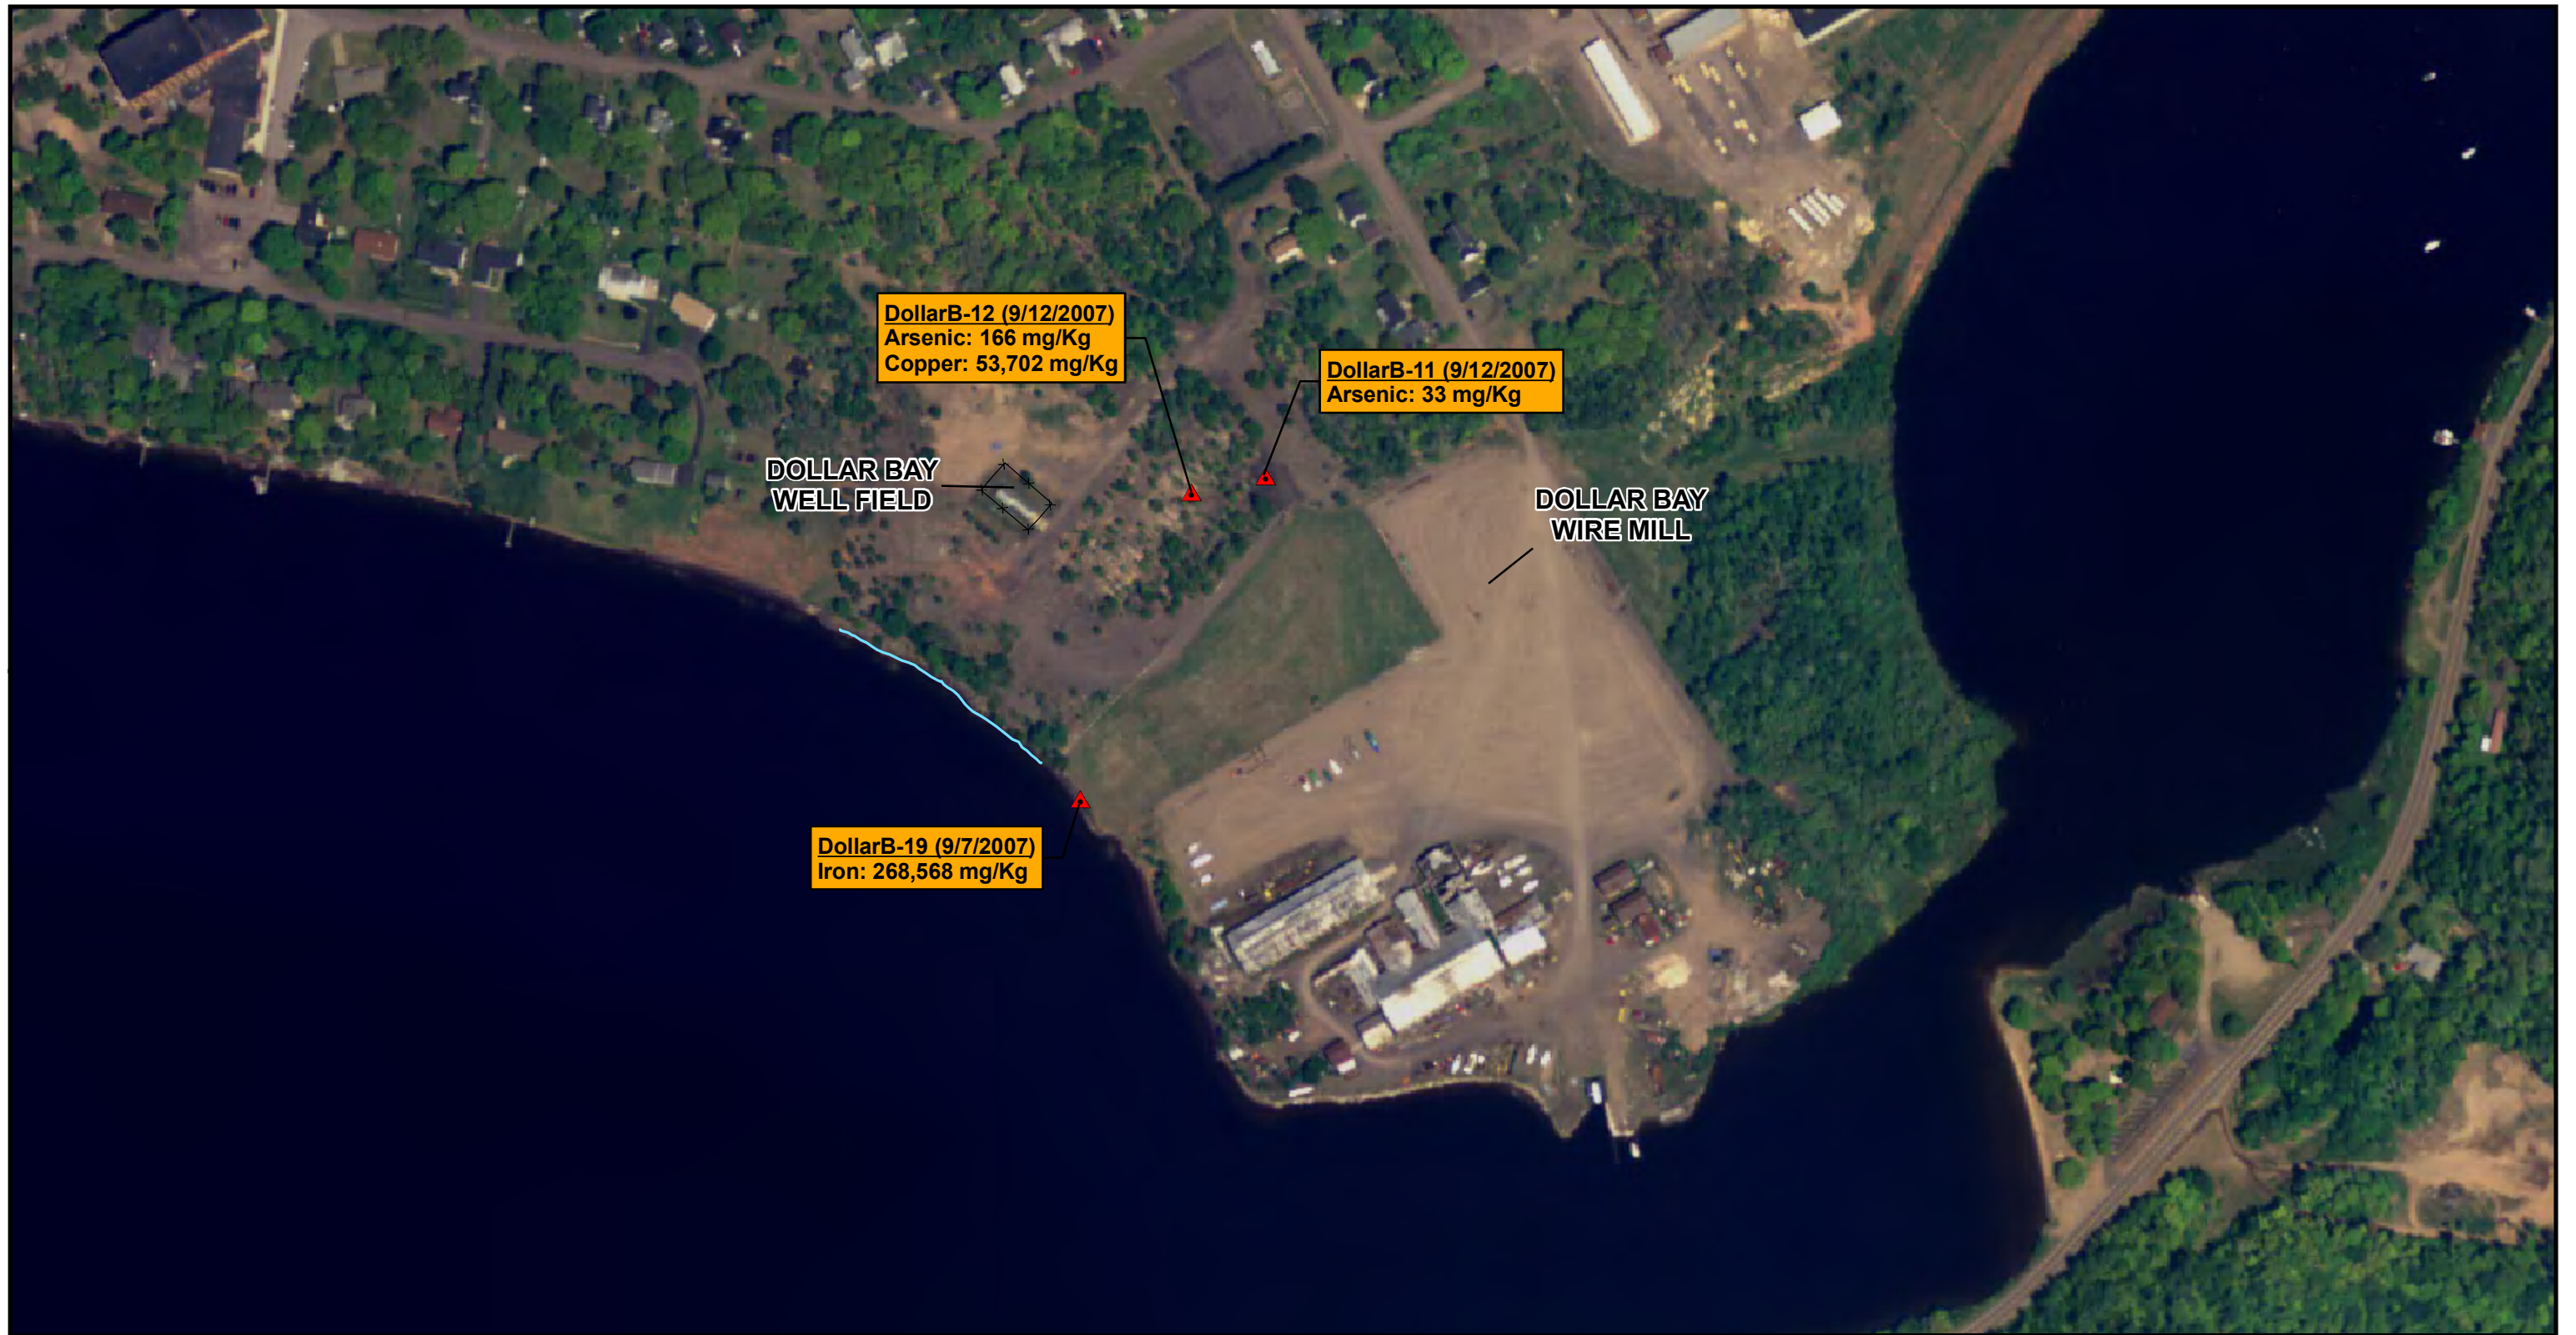
Figure 3a

AOI Nos. 16 and 17
SITE FEATURES AND XRF LOCATIONS
TORCH LAKE AREA ASSESSMENT
KEWEENAW PENINSULA, MICHIGAN
 October 2007

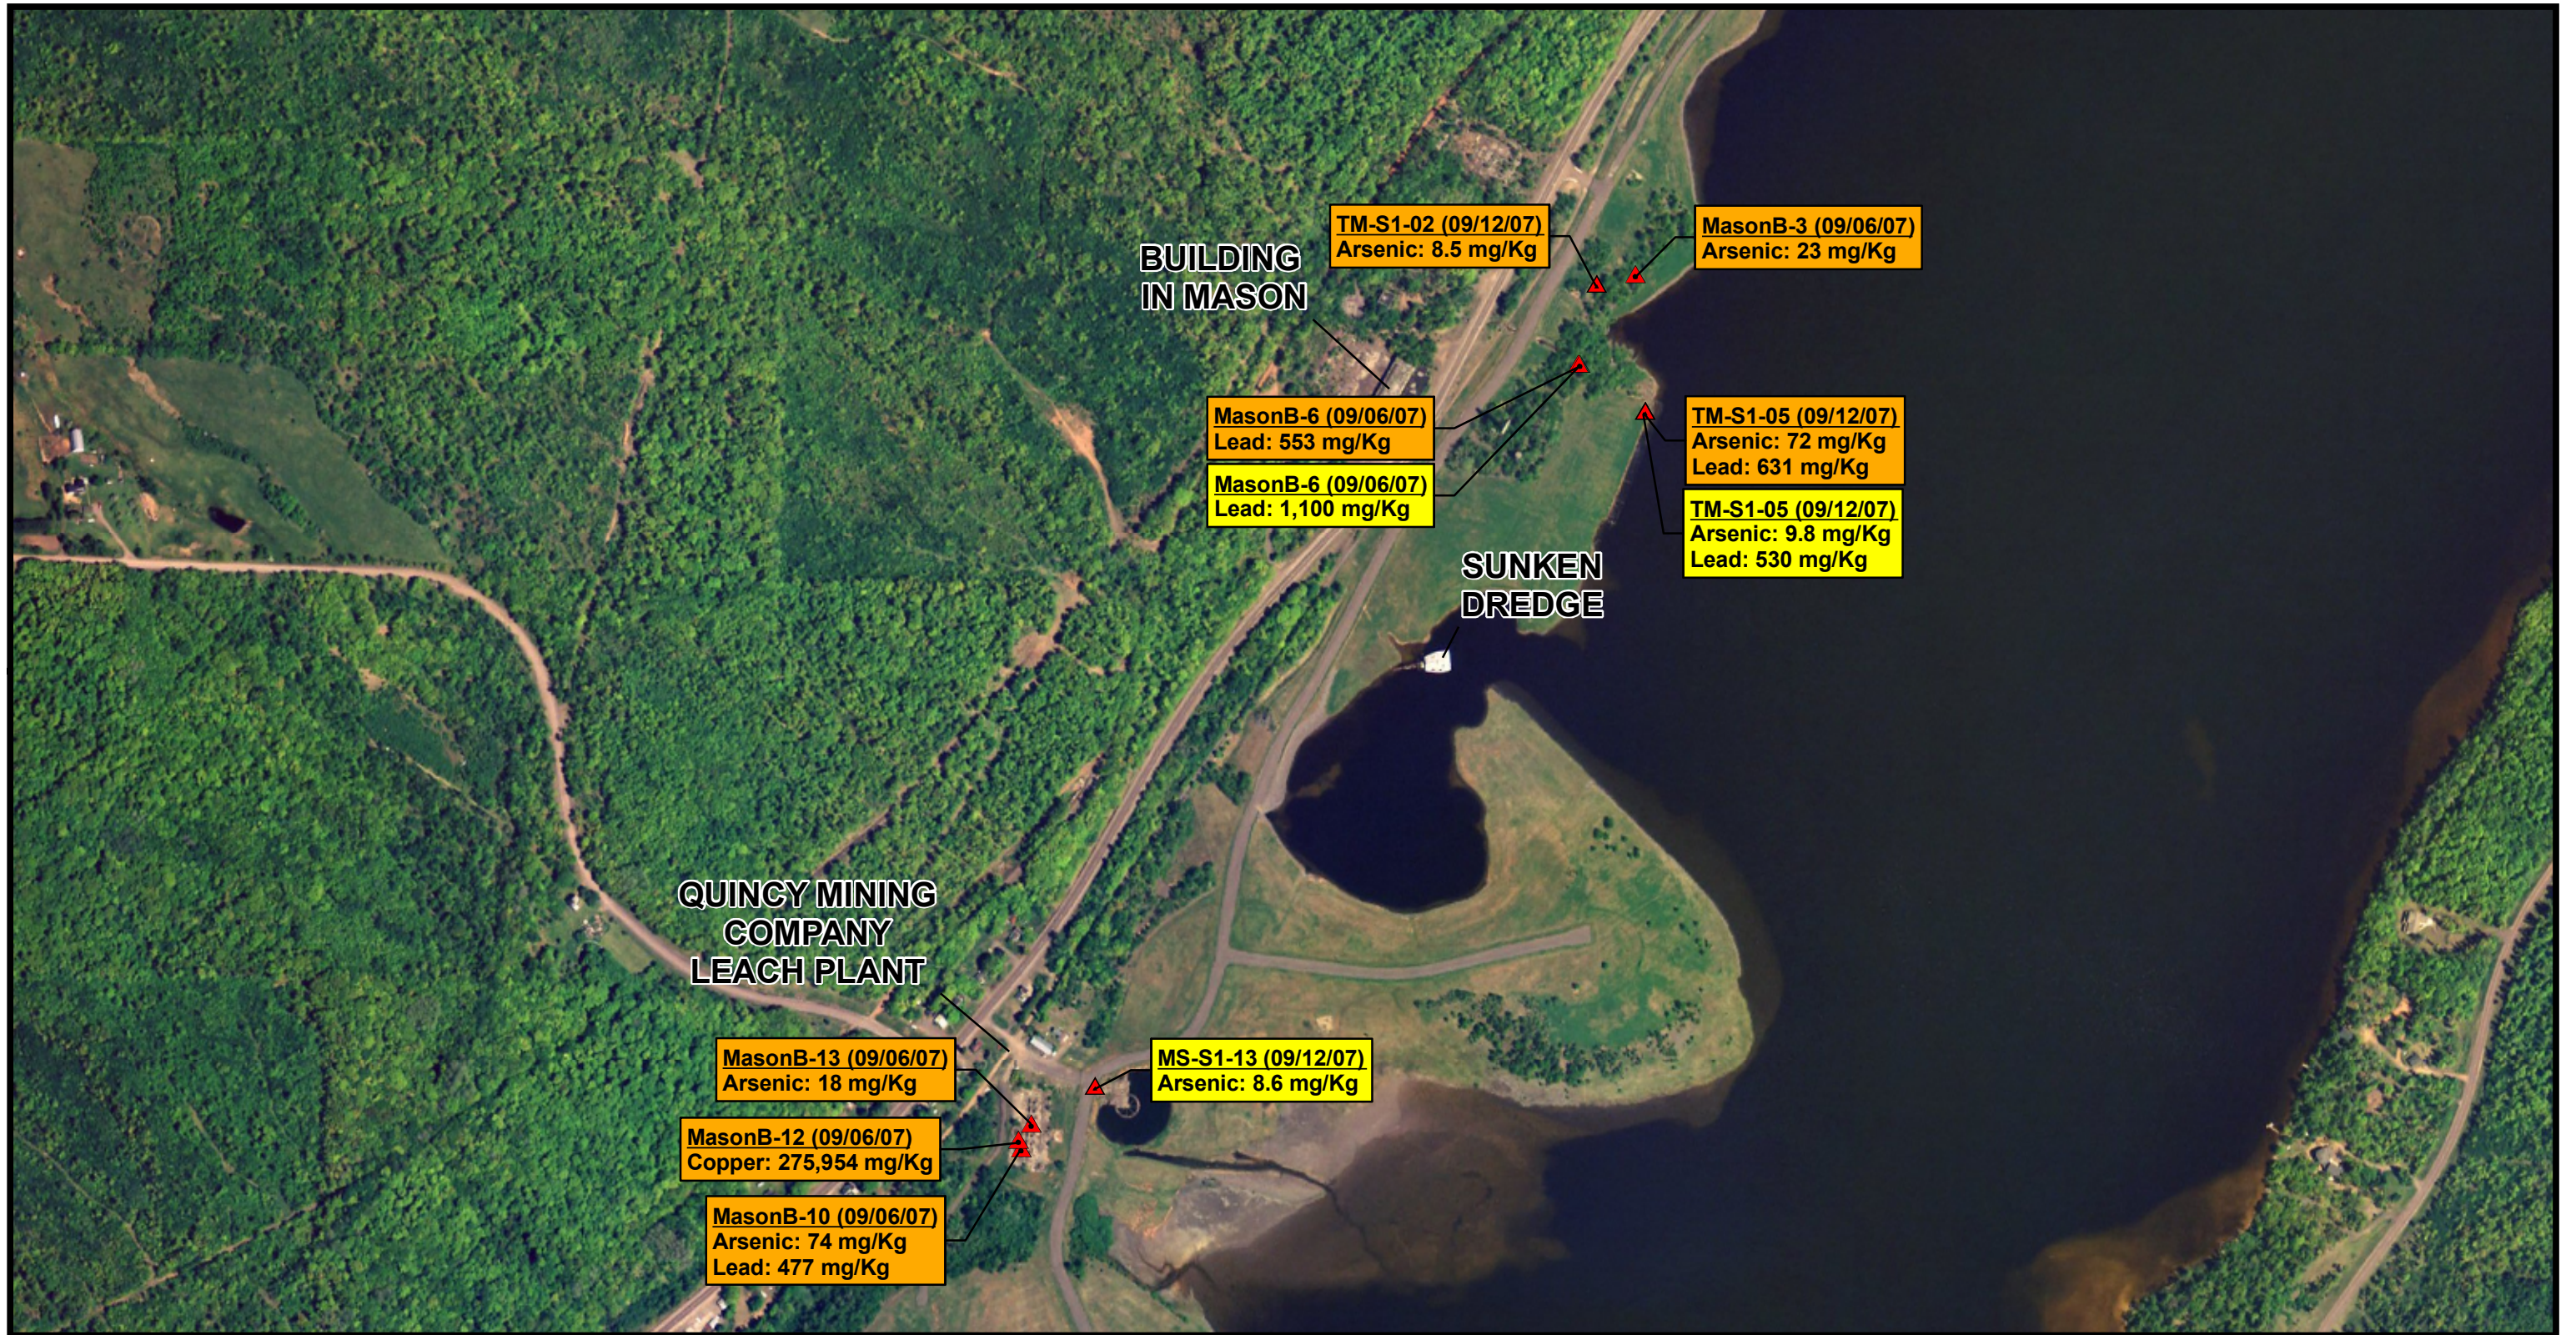
Figure 4a

AOI Nos. 10 and 18
SITE FEATURES AND XRF LOCATIONS
TORCH LAKE AREA ASSESSMENT
KEWEENAW PENINSULA, MICHIGAN
October 2007

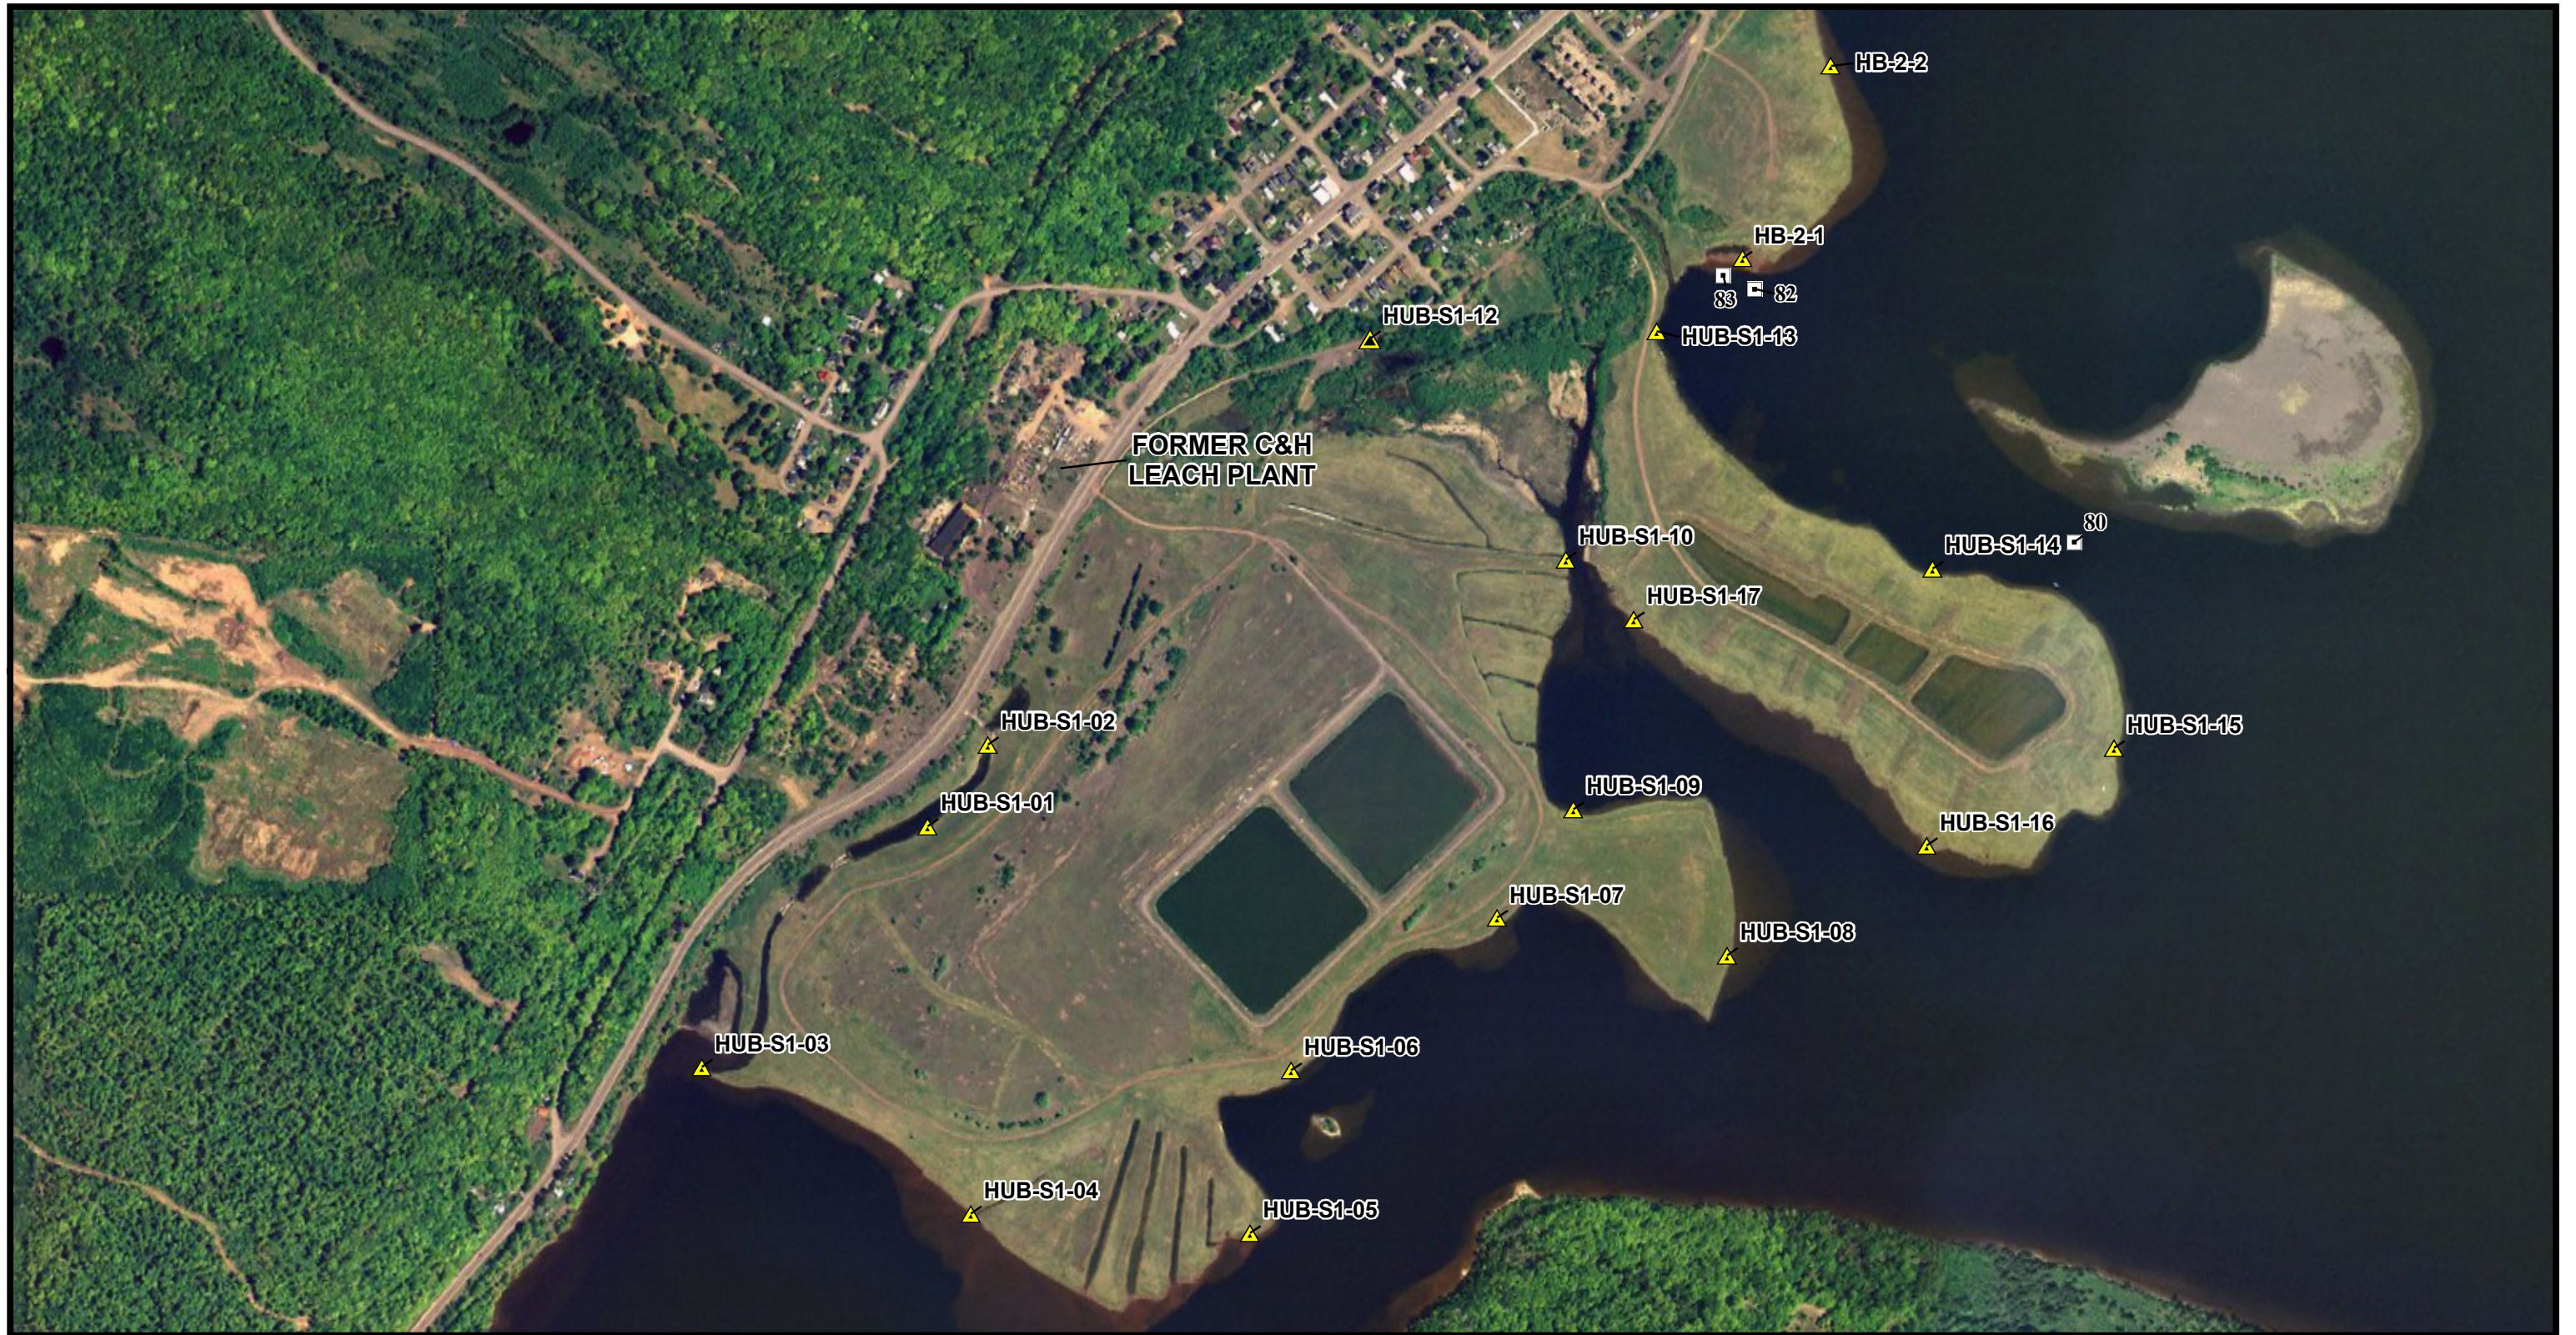
Figure 4b

AOI Nos. 10 and 18
RDCC EXCEEDANCES IN SOIL
TORCH LAKE AREA ASSESSMENT
KEWEENAW PENINSULA, MICHIGAN
October 2007
